**COMPACTION AT THE LONGITUDINAL CONSTRUCTION JOINT  
IN ASPHALT PAVEMENTS (KYSR-00-208)**

Research Report  
KTC-02-10/SPR208-00-1F

**COMPACTION AT THE LONGITUDINAL CONSTRUCTION JOINT  
IN ASPHALT PAVEMENTS (KYSPR-00-208)**

May 2002

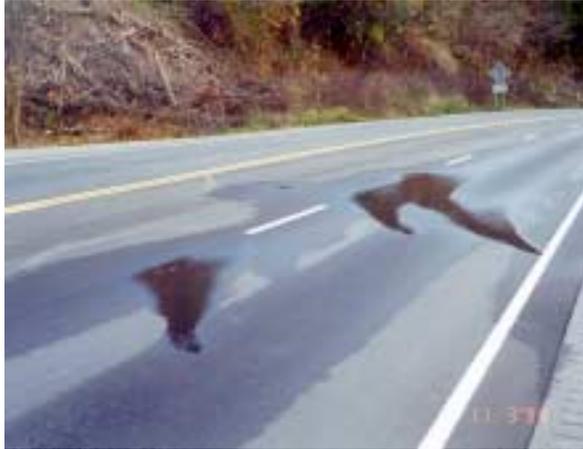
**Figure 1.** US 460, Pike County.

In recent years, it has become evident how critical proper longitudinal joint construction is to the life of the pavement structure. Recent water and icing problems on US 460 (Figure 1) and US 23 in Pike County, premature pavement failures on I-75 in Scott County (Figure 2), and other problems found throughout the state (Figure 3) indicate that construction joints may be allowing water to rapidly enter the pavement structure. The water appears to be causing several problems such as debonding of surface layers, mixture stripping, aging of the asphalt (oxidizing and hardening), and other associated problems, all of which accelerate pavement failure. Many pavements have been, or are in the process of being, resurfaced as a direct or indirect result of longitudinal joint deterioration.

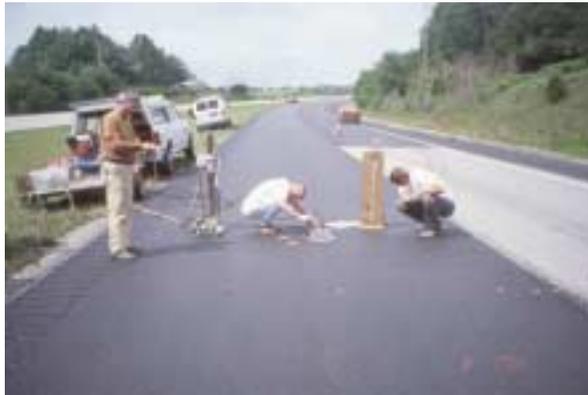
**Figure 5.** Permeability/vacuum testing being conducted on newly placed surface.

Field testing was conducted shortly after the final compaction of the mix and prior to any traffic being placed on the pavement (Figure 5).

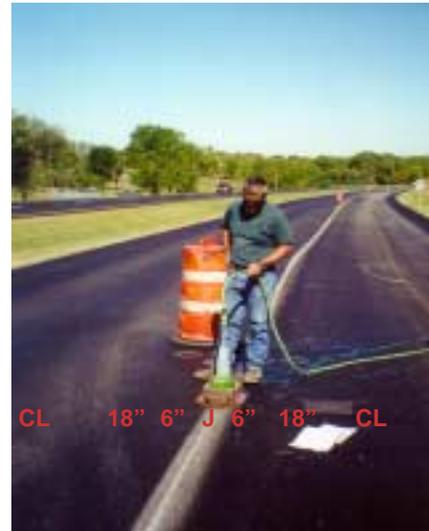
**Figure 4.** Photo indicating test locations.

pavement. As shown in Figure 4, field tests and core samples were taken at the centerline on the longitudinal joint, and at six inches, 18 inches, and six feet (CL, the center of the lane) on each side of the joint.

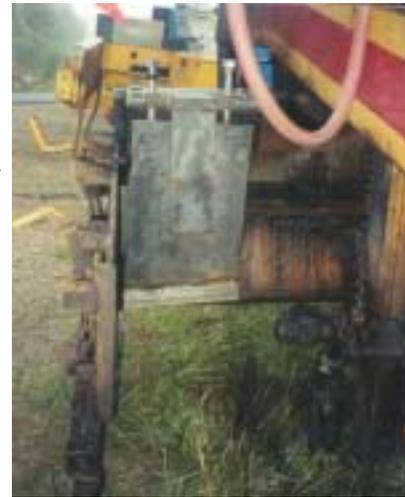
**Figure 6.** Made-in-house notched-wedge device.

The notched-wedge joint construction method was utilized on four research projects and on a demonstration project on US 150 (Figure 8) prior to the initiation of this study. The majority of the contractors opted to build their own notched-wedge device (Figure 6), but one contractor purchased a notched-wedge device through Trans Tech (Figure 7). Both devices produced similar joints in appearance. The joints were required to be constructed with a 0.5-inch upper and lower notch and a 12:1 taper between the upper and lower notch.

The notched-wedge device is mounted on the edge of the paver, adjacent to the end gate, and in front of the screed. The device is then adjusted below the screed to form the wedge in the newly placed HMA. A small tow-behind roller weighing approximately 400 pounds or greater is pulled along the wedge to provide some additional compaction (Figure 8).

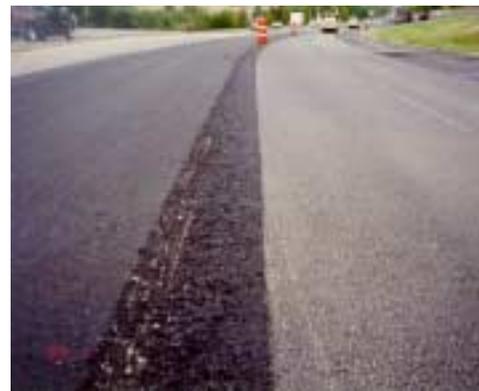
**Figure 9.** Raveling of bottom section of wedge.

The major problems associated with the notched-wedge joint were maintaining the upper notch during compaction, raveling on the lower portion of the wedge (Figure 9), and aggregate pickup by the small wedge roller. Problems were also observed on US 62 during the construction of a notched wedge on a base course. It appeared that the notched-wedge device was placing enough drag on the paver to twist the paver sideways slightly out of plane, making it difficult to use the ski poles. A portion of this twisting appears to have been caused by material being forced under the end gate, creating additional “sideways drag” on the paver.

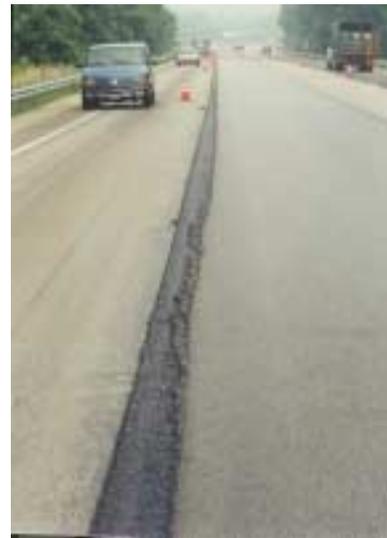
**Figure 10.** Bulging upper portion of wedge.

Most of the problems observed with the notched wedge were controllable. The upper notch was “over-cut” during the initial screeding to allow for compaction of the HMA. The raveling appeared to be caused by the lower notch being cut too small. This phenomenon was mostly observed on the US 150 project in which the new surface was only one inch thick. Bulging of the notch was observed on US 31W; this imperfection appears to be due to tender mix characteristics (Figure 10). It appears that the wedge was restraining the mix from pushing sideways during compaction, thus causing some bulging in the wedge.

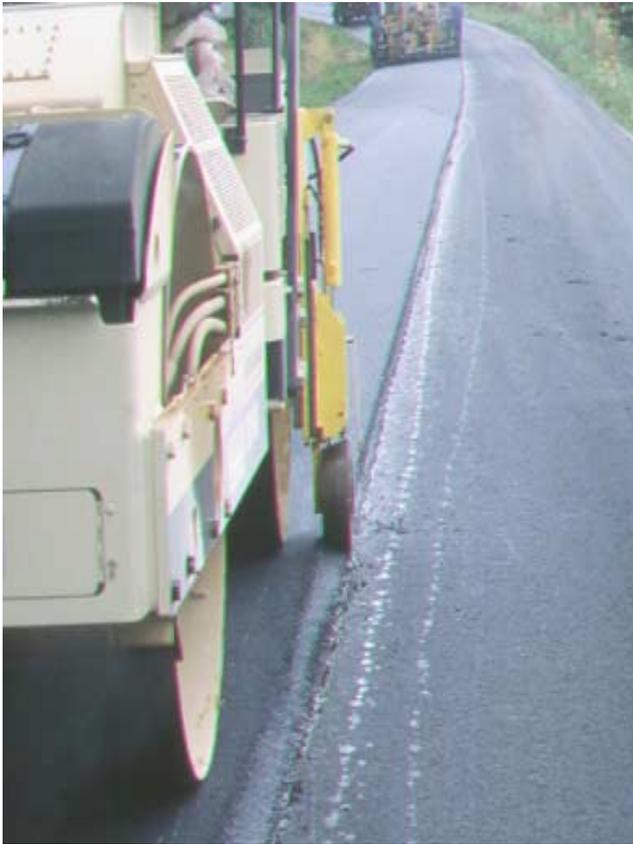
**Figure 15.** Restrained-edge compaction of new asphalt surface.

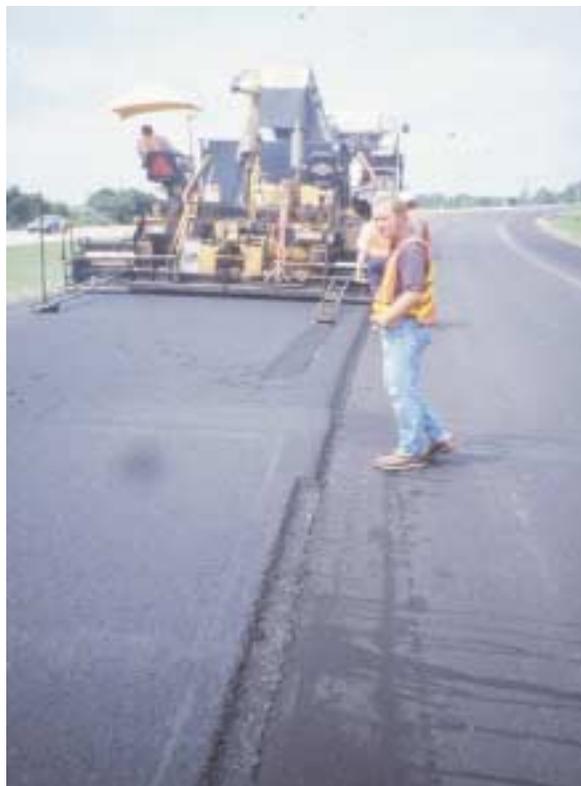
**Figure 16.** Compaction of 1.5-inch surface on KY 80.

The restrained-edge device was first utilized on US 68/KY 80 in Barren County which was a one-inch lift. The device left a densely compacted, smooth face along the edge of the mat (Figure 15). The device was also tried on 1.5-inch lift on KY 80 in Laurel County. The beveled wheel did not have enough height to properly compact the uncompacted material (Figure 16). The restraining wheel caused the mixture to push up on the inside edge of the restraining wheel, creating a longitudinal ridge in the mat. It was necessary to make two passes with the breakdown roller prior to restraining the edge. This pattern allowed the mix to be compacted enough so that the beveled edge of the restraining wheel was now of sufficient height to cover the edge of the asphalt mat. Allowing for two passes with the breakdown roller and then restraining the mix likely decreased the effectiveness of the restraining method as the material had already been allowed to push to the side in an unrestrained state. It was concluded by the Study Advisory Committee (SAC) for this research project that the wheel needed to be modified and additional projects would be constructed for further evaluation (US 431 in Logan County and US 27 in Pulaski County).

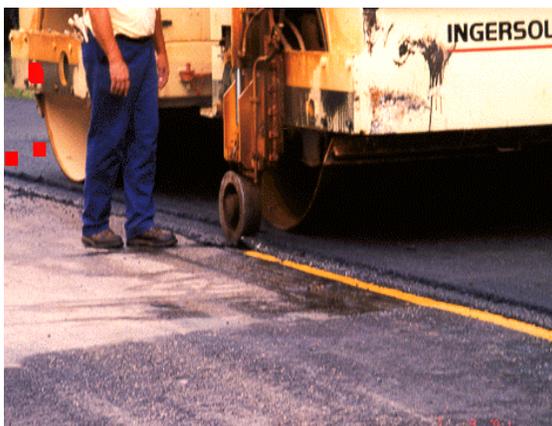
**Figure 17.** HMA pushing up in front of restraining wheel.

The same restraining wheel was used at the start of the US 431 project in Logan County without any modifications. Again, the restraining wheel displaced the mixture vertically where the beveled edge of the wheel was not of sufficient dimension to cover the entire uncompacted edge of the surface. Multiple passes with the restraining wheel were tried, which eliminated some of the humping, but this pattern started to push and/or pull the mix in front of the restraining wheel (Figure 17).

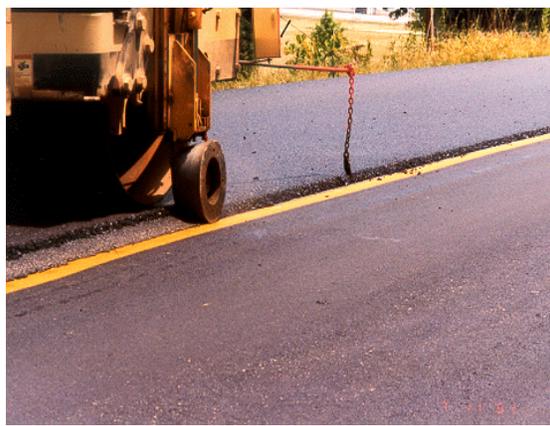
**Figure 18.** Wider restrained-edge wheel on US 431.

On the same project, the tapered section of the wheel was increased so that it covered the entire uncompacted face of the mixture (Figure 18). The mix appeared to be slightly tender and was pushing up between the main drum and the restraining wheel; additional compaction with the main drum created a longitudinal crack along the edge. The initial rolling pass was then performed with the main drum, and the restraining device was utilized on the second pass. This pattern allowed for some lateral movement in the mixture and densification prior to restraining the mixture on the second pass. This approach likely reduces the density of the mixture since it is not restrained on the first pass.

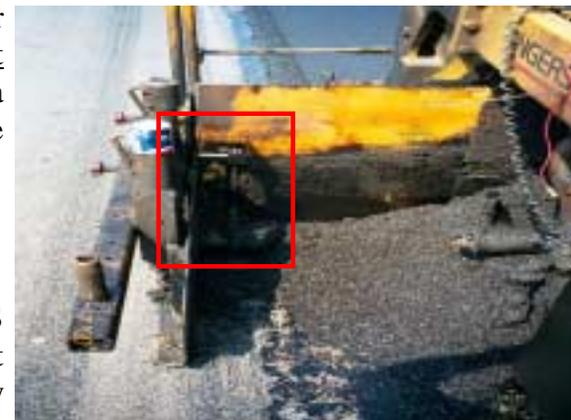
**Figure 24.** Joint Maker mounted to paver (highlighted in red box).

The Joint Maker system, manufactured by Trans Tech, was used on three construction projects (US 68/KY 80 in Barren Co., US 460 in Menifee Co., and US 41 in Webster Co.). The Joint Maker is a non-mechanical device that is mounted on the front side of the screed next to the end gate. The Joint Maker is a large, rounded-edge metal mass that adds some initial compaction to the mixture prior to going under the paver screed. The Joint Maker is mounted approximately 0.5 inch above the bottom of the screed and is set at a 30-degree upward angle from the pavement surface (Figure 23). The Joint Maker device is shown as highlighted (red box) in Figure 24. In addition to the Joint Maker, several of the projects included the Joint Matcher and Kicker Plate also manufactured by Trans Tech. The Kicker Plate rides adjacent to the end gate and helps to form a more vertical edge for a smoother joint. The Joint Matcher automatically controls the edge gate for proper matching of the joint (Figure 25). Both the Joint Matcher and Kicker Plate may help to provide a cleaner-looking joint and contribute some to the overall density of the joint.

The Joint Maker system was initially used on the US 68/KY 80 project in Barren County. The biggest problem associated with the Joint Maker was correctly setting up the device prior to paving. The correct positioning of the device was unclear to the contractor. Dragging of the mixture was also noticed at the start of paving. This phenomenon was prevented by preheating the Joint Maker before paving.

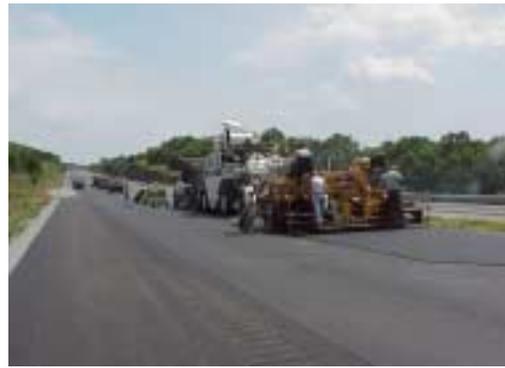
**Figure 29.** Infrared joint reheater on Bluegrass Parkway.

The purpose of the system is to reheat the initially paved surface (cold joint) and bring it up to a plastic state prior to the new, adjacent hot mat being laid. This reheating permits better consolidation of the mat at the joint, thus making the joint denser and less permeable.

A total of three infrared reheaters were used on the project (Figure 29). Two infrared preheaters were pulled approximately 100 feet in front of the paver (Figure 30), and the third reheater was mounted directly onto the paver (Figure 31). The purpose of the two preheaters in front of the paving train was to supply some initial heat to the pavement to penetrate into the mix. The third heater then gives the pavement another infusion of heat which brings the “cold joint” back up to its plastic state (paving temperature). Surface temperatures after reheating are shown in Figure 32.

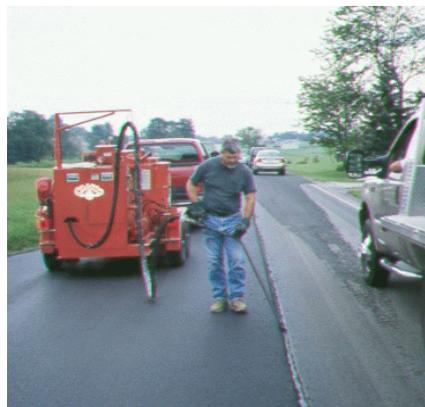
**Figure 36.** Crafco being placed on US 68/KY 80.

Two types of joint adhesives were used on five of the research projects: a hot-melt poured adhesive called Crafco (Figure 36) and a HMA joint tape called Tbond (Figure 37).

Crafco joint adhesive was used on two demonstration projects and one project let to bid. The adhesive was applied to several conventional joints, a notched-wedge joint (Figures 38 and 39), and restrained-edge joint. These applications are listed in Table 2. Crafco is a hot-poured adhesive that is applied in a similar manner to a crack sealant. The material is very tacky, and a releasing agent (Detack or Glenzoil 20) is recommended to reduce pickup by the tires on conventional traffic and construction vehicles.

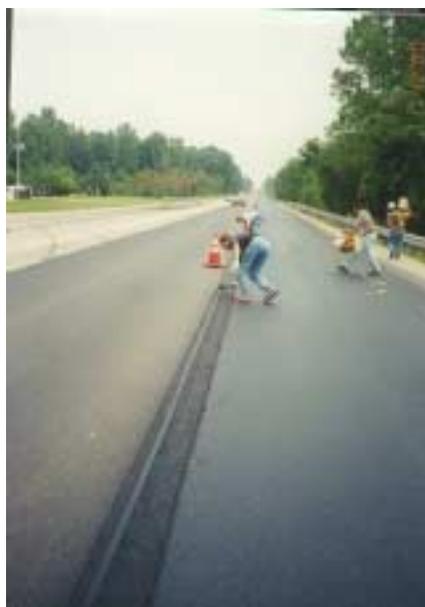
**Figure 37.** Asphalt joint tape being placed on notched-wedge joint on US 31W.

The HMA joint tape was applied on the US 31W project in Meade and Hardin Counties in both the notched-wedge and control sections. The tape was delivered to the site in boxes and rolled out into place in 10-m (40-mm wide x 6-mm thick) rolls. The tape was attached to the pavement with occasional tacks and/or by hammering the tape onto the asphalt.

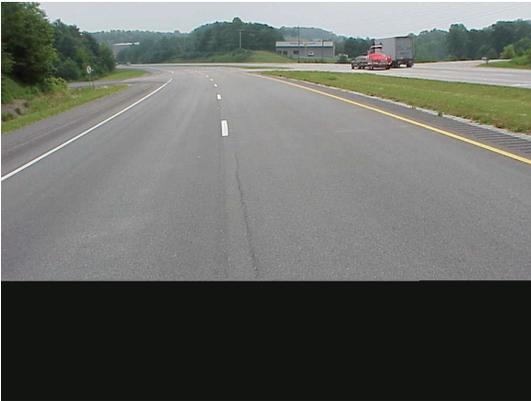
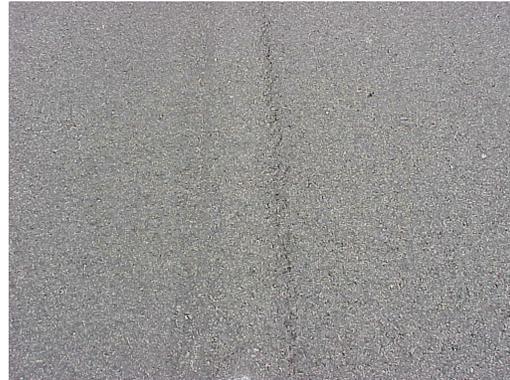
The cracking that was observed in the restrained-edge section of KY 80 in Laurel County is occurring in the area that had “pushed up” between the main drum and restraining wheel during construction. Cracking was also observed in this location on the mat on US 431 in Logan County during construction using the same roller and restraining wheel. However, the crack on US 431 disappeared during compaction and currently no crack is visible.

**Figure 61.** Cracking in restrained-edge section on KY 80.

**Figure 62.** Cracking in restrained-edge section on KY 80.

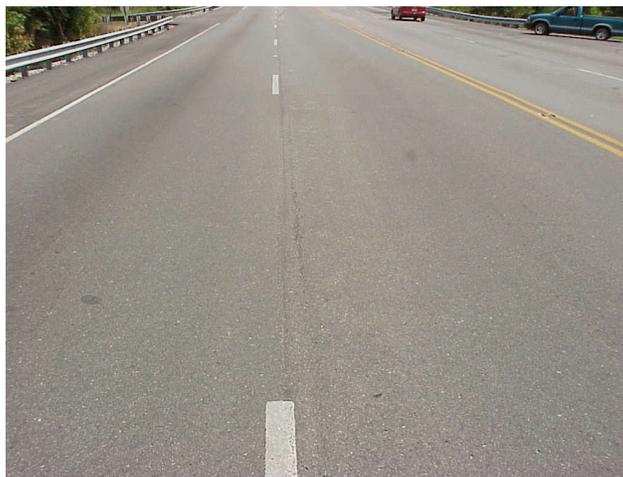
**Figure 63.** Cracking in control section on US 31W.

Between 1999 and 2000, eight of the 12 joint projects listed in this study were constructed. Performance information is contained in Table 5. Visual performance data indicate that cracking is occurring in a number of the projects. Cracking was observed in the restrained-edge section of the KY 80 project in Laurel County (Figures 61 and 62) and in the control section on the US 31W project in Hardin and Meade Counties (Figure 63). It appears the crack in the control section on US 31W was located over an old construction joint. In addition, two other projects (US 460, Menifee County and US 68/KY 80, Barren County) have slight-to-moderate cracking.
